# Allied-Axis

THE PHOTO JOURNAL OF THE SECOND WORLD WAR

## Karl-Gerät 040 at the front

Panzerjäger I • SdKfz. 10 1-ton halftrack  
U.S. M2 Treadway Bridge • PzKpfw. IV Ausf. A  
Type 97 Japanese medium tank

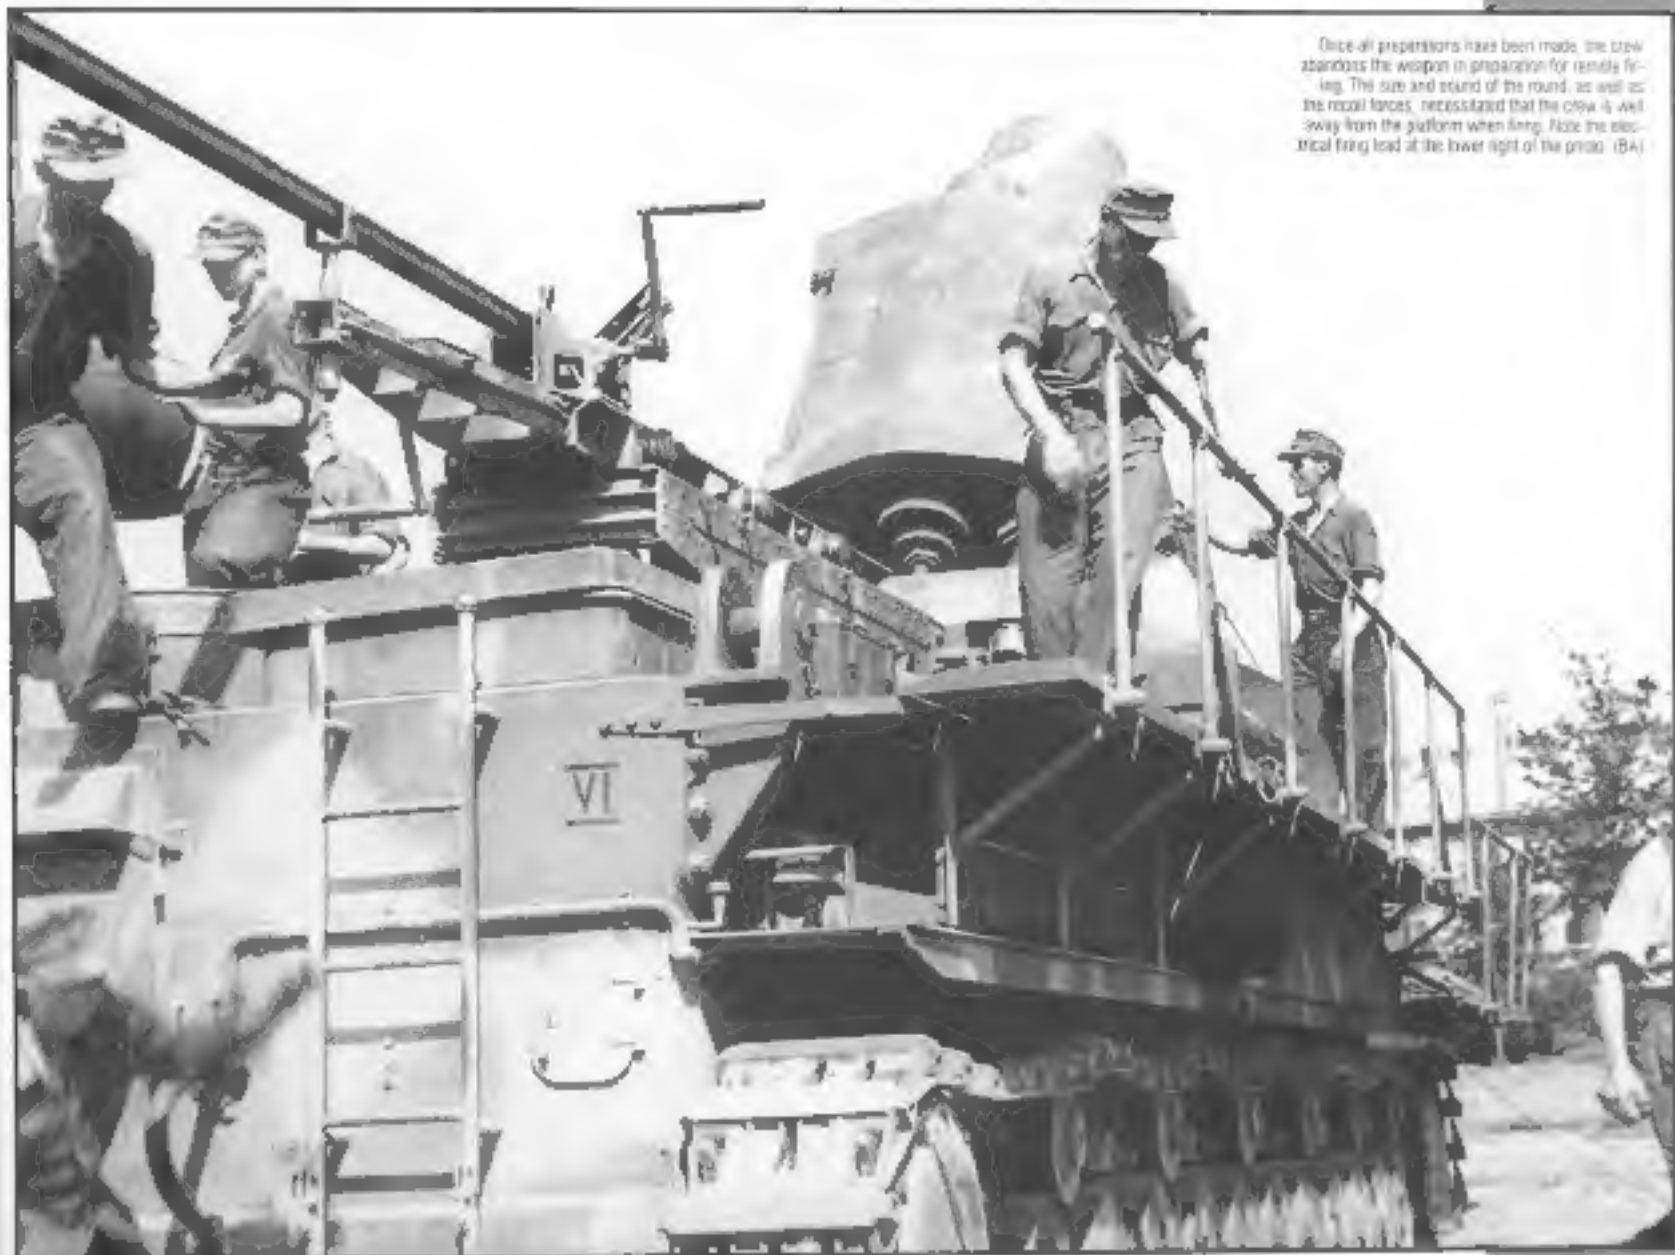
Once all preparations have been made, the crew abandons the weapon in preparation for remote firing. The size and sound of the round, as well as the recoil forces, necessitated that the crew is well away from the platform when firing. Note the electrical firing lead at the lower right of the photo. (BA)

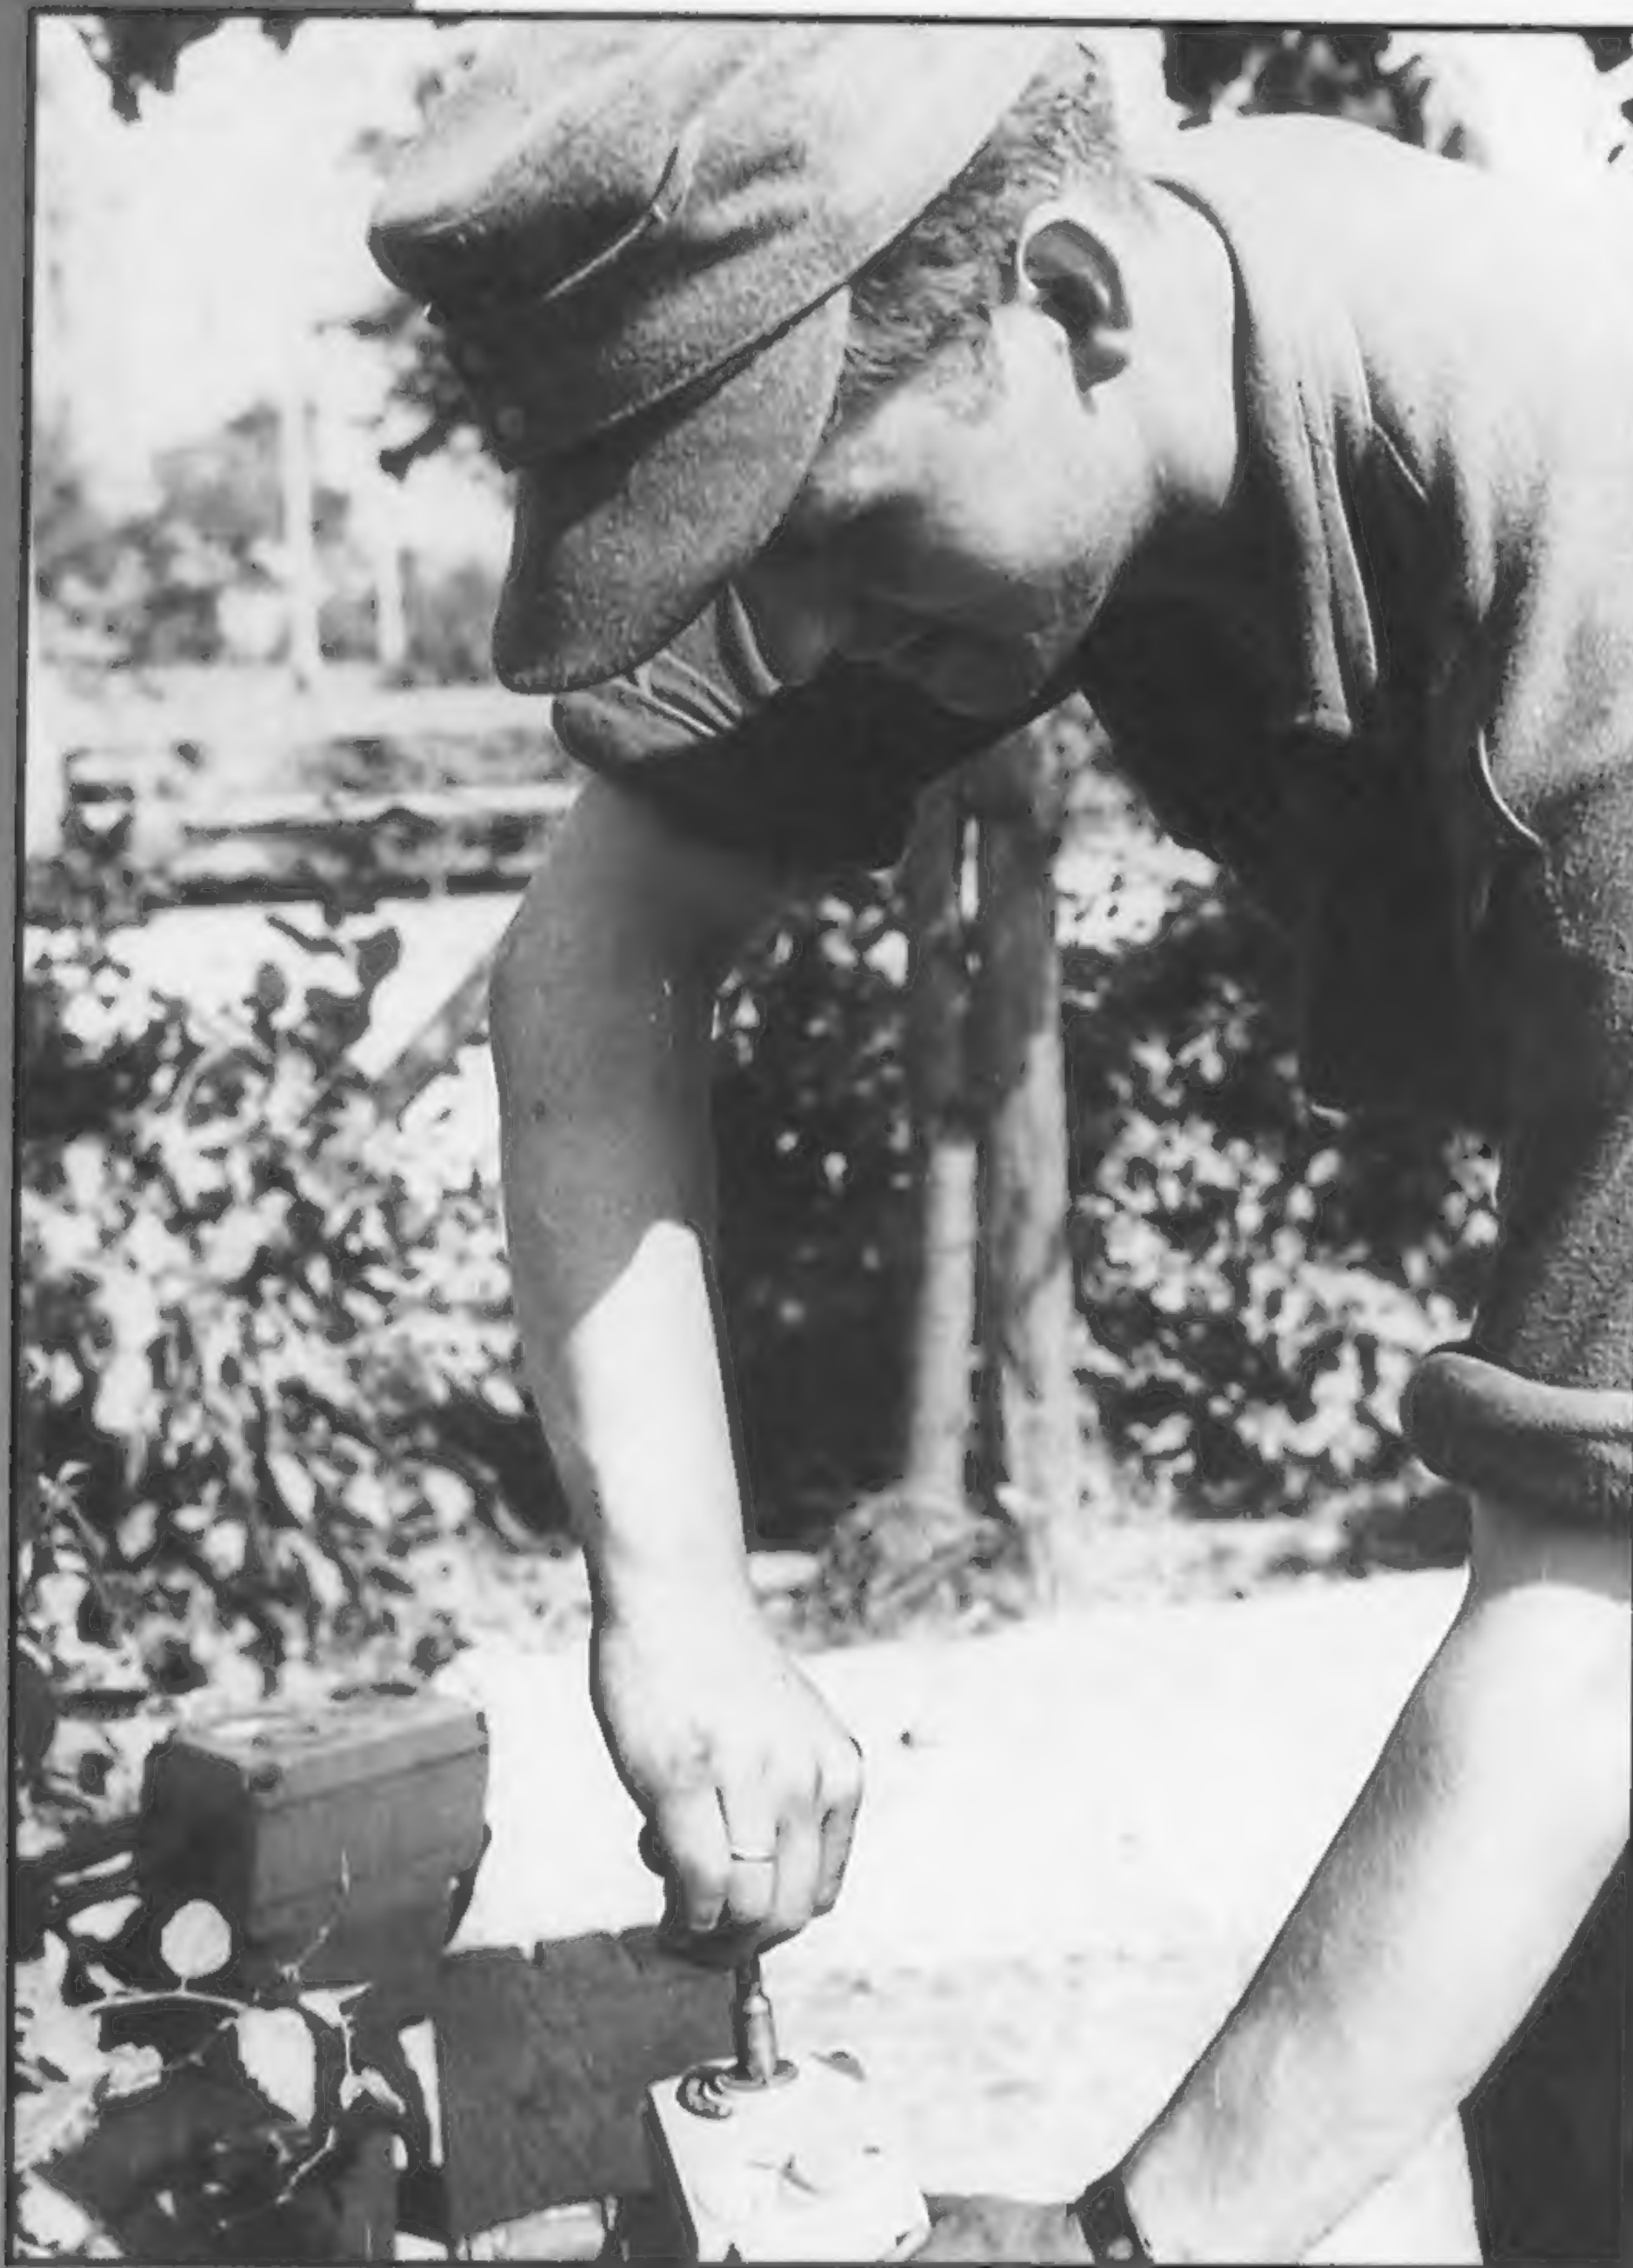
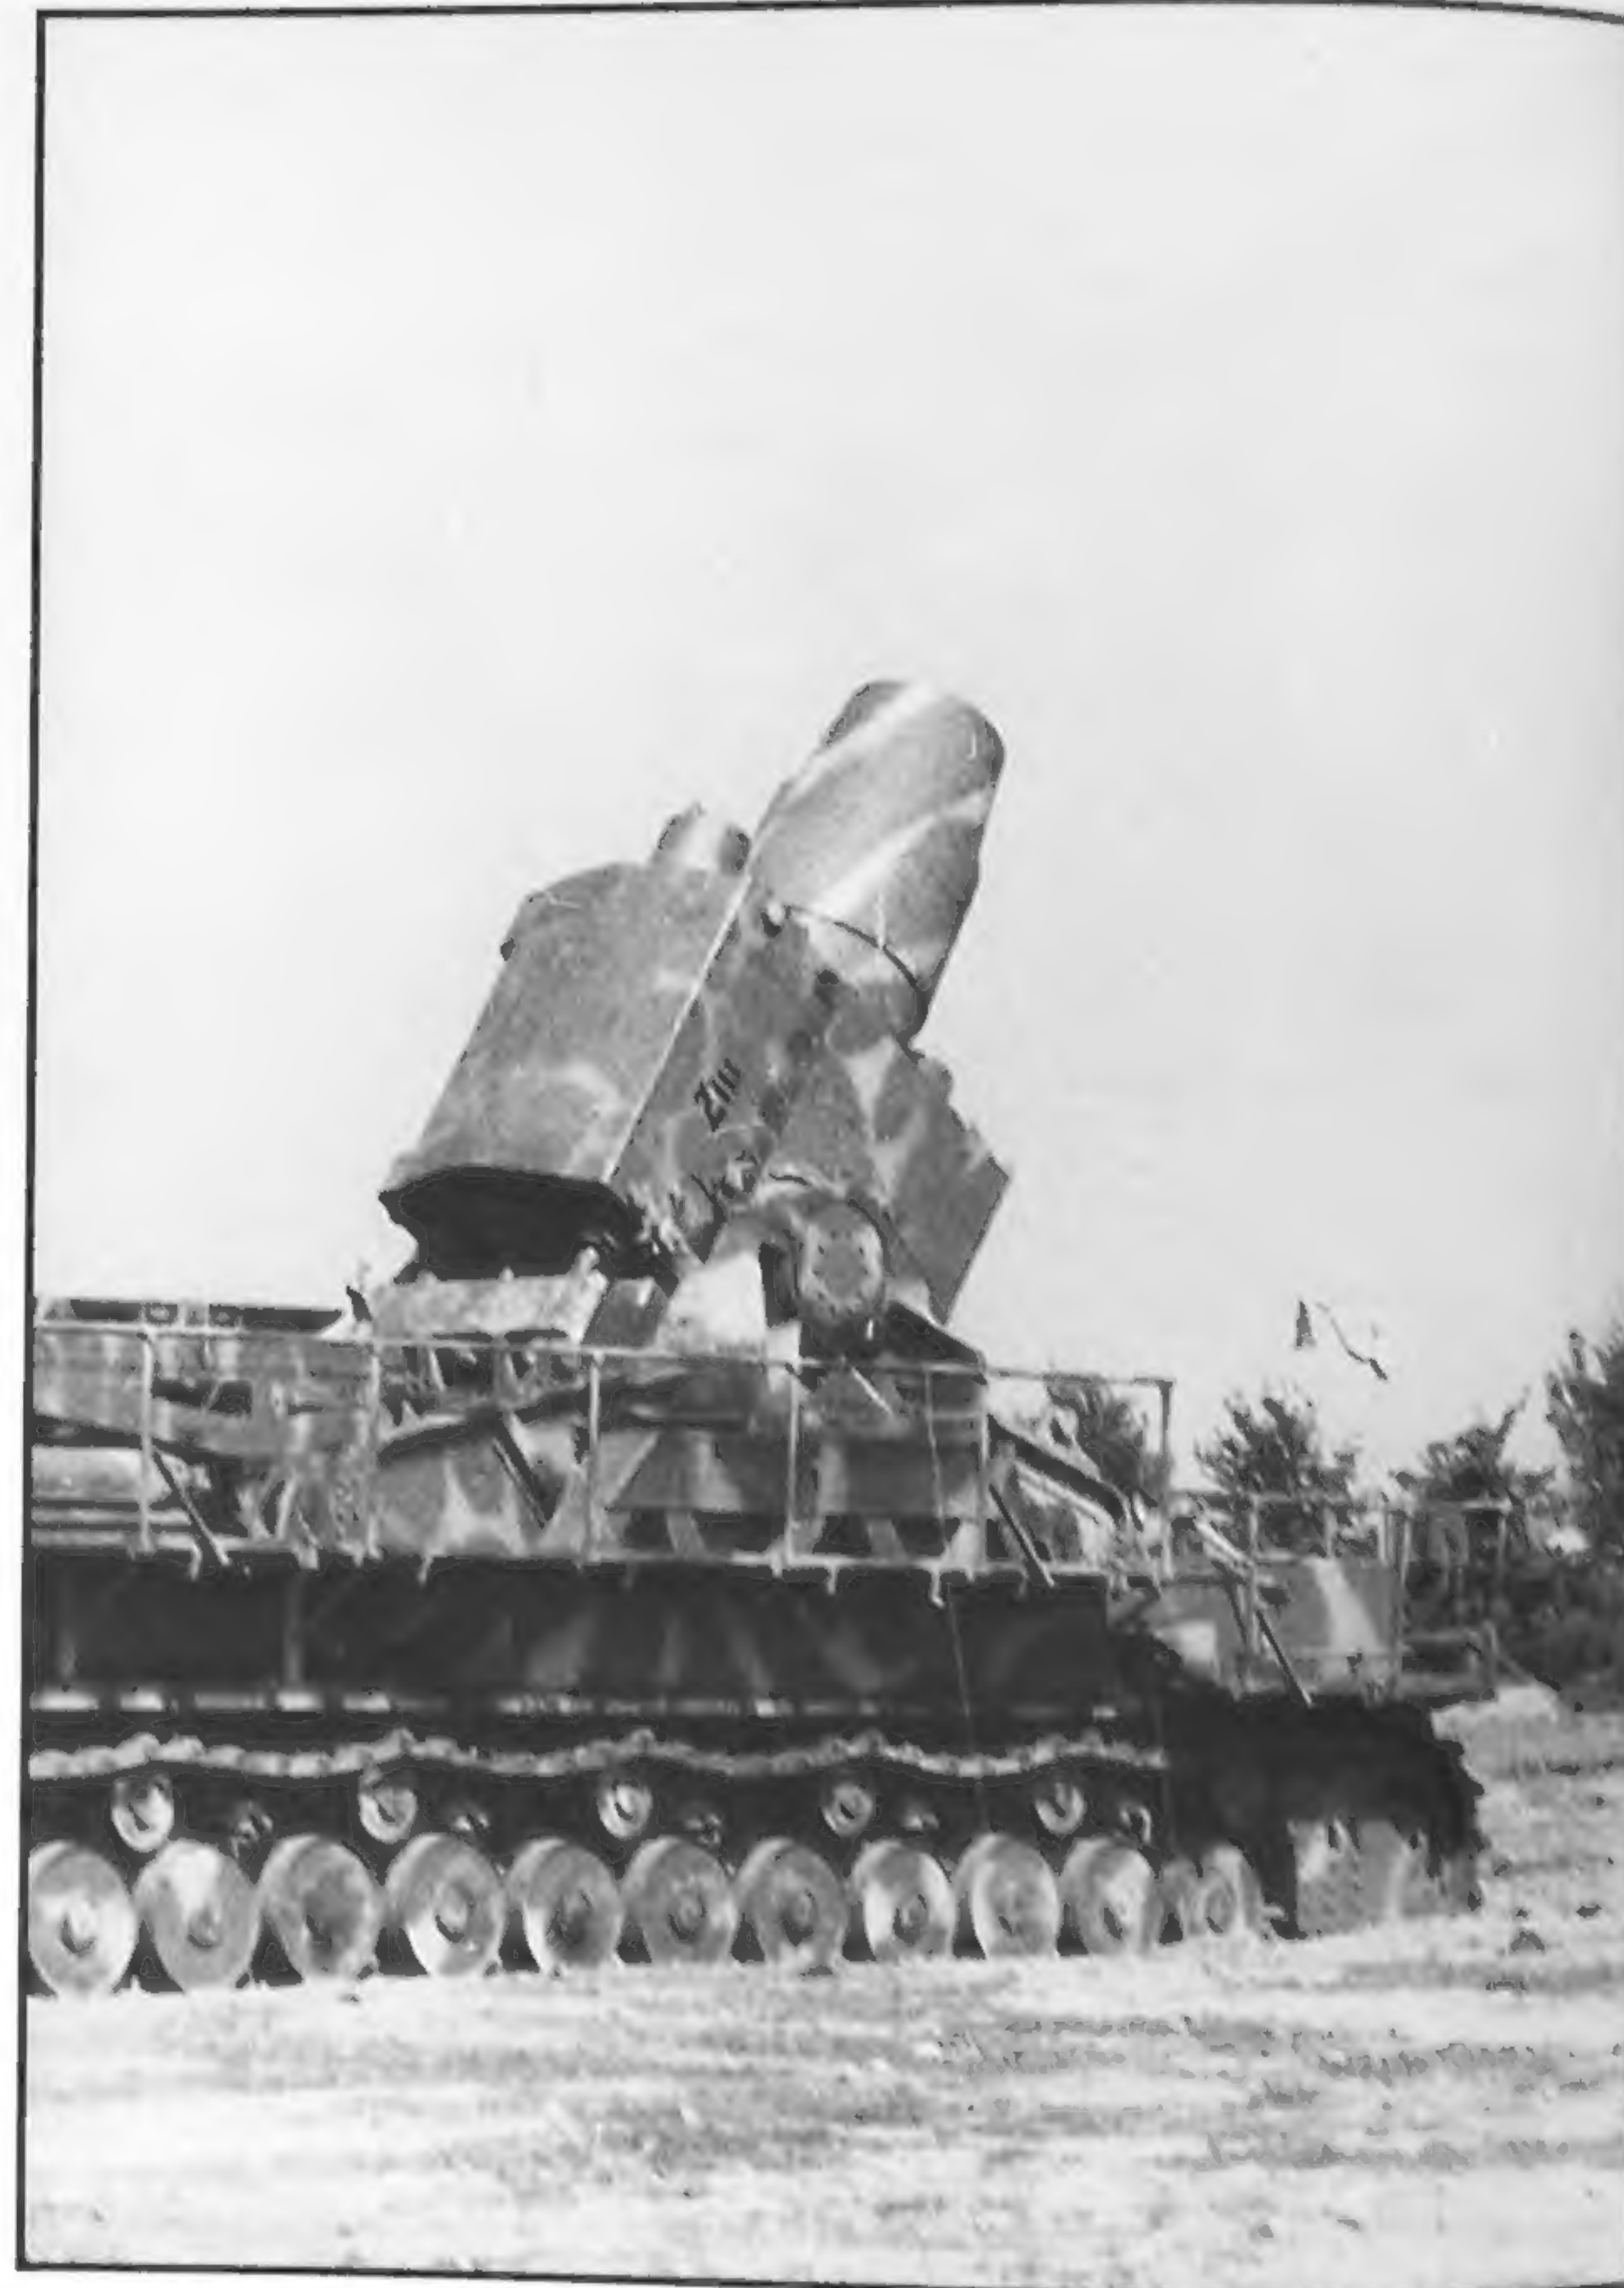
**Above left:** At a suitably safe distance, one of the crew prepares to detonate the round. Detonation was by plunger, as seen in the gunner's right hand. (BA) **Above right:** The final moments prior to firing. Two different types of suspension were used on the Karl-Gerat. Guns I and II used an eight-wheeled

rubber rimmed configuration, while guns III through VI used 11 steel wheels on each side. These two configurations also differed in the track type and pitch, the torsion bars and the drive sprockets. (BA)

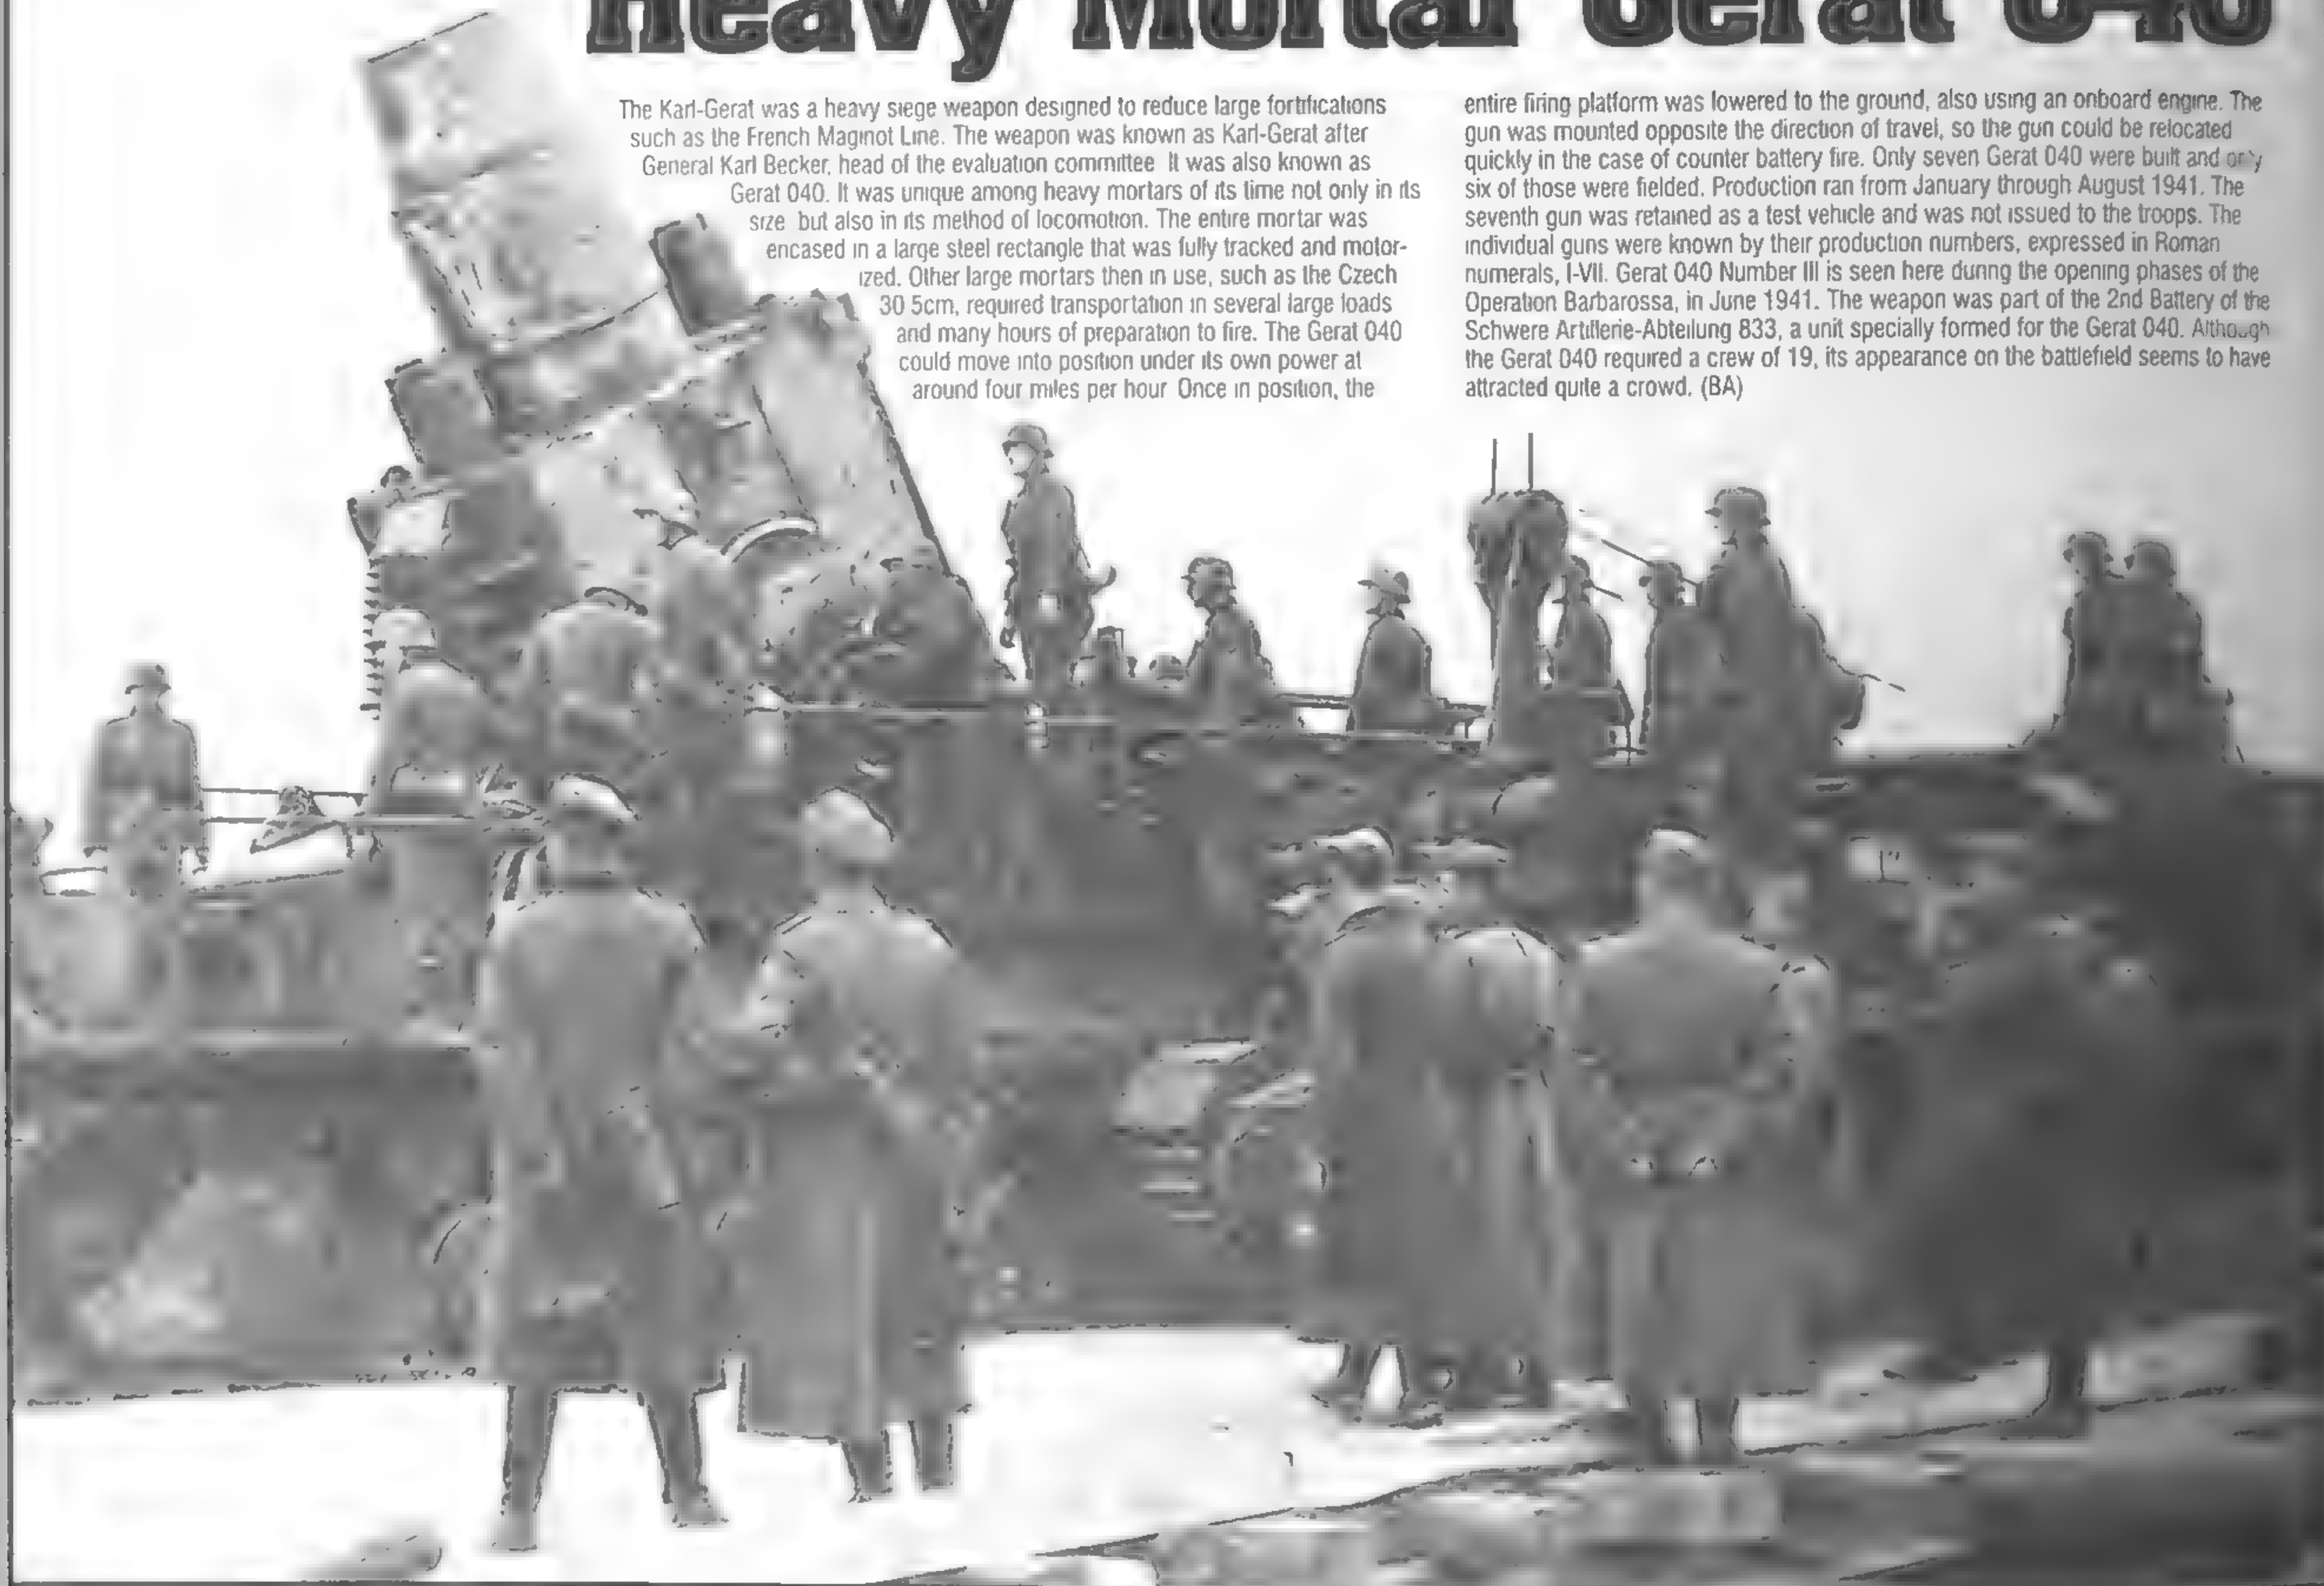
The Karl-Gerat was a heavy siege weapon designed to reduce large fortifications such as the French Maginot Line. The weapon was known as Karl-Gerat after General Karl Becker, head of the evaluation committee. It was also known as Gerat 040. It was unique among heavy mortars of its time not only in its size but also in its method of locomotion. The entire mortar was encased in a large steel rectangle that was fully tracked and motorized. Other large mortars then in use, such as the Czech 305cm, required transportation in several large loads and many hours of preparation to fire. The Gerat 040 could move into position under its own power at around four miles per hour. Once in position, the

entire firing platform was lowered to the ground, also using an onboard engine. The gun was mounted opposite the direction of travel, so the gun could be relocated quickly in the case of counter battery fire. Only seven Gerat 040 were built and only six of those were fielded. Production ran from January through August 1941. The seventh gun was retained as a test vehicle and was not issued to the troops. The individual guns were known by their production numbers, expressed in Roman numerals, I-VII. Gerat 040 Number III is seen here during the opening phases of the Operation Barbarossa, in June 1941. The weapon was part of the 2nd Battery of the Schwere Artillerie-Abteilung 833, a unit specially formed for the Gerat 040. Although the Gerat 040 required a crew of 19, its appearance on the battlefield seems to have attracted quite a crowd. (BA)

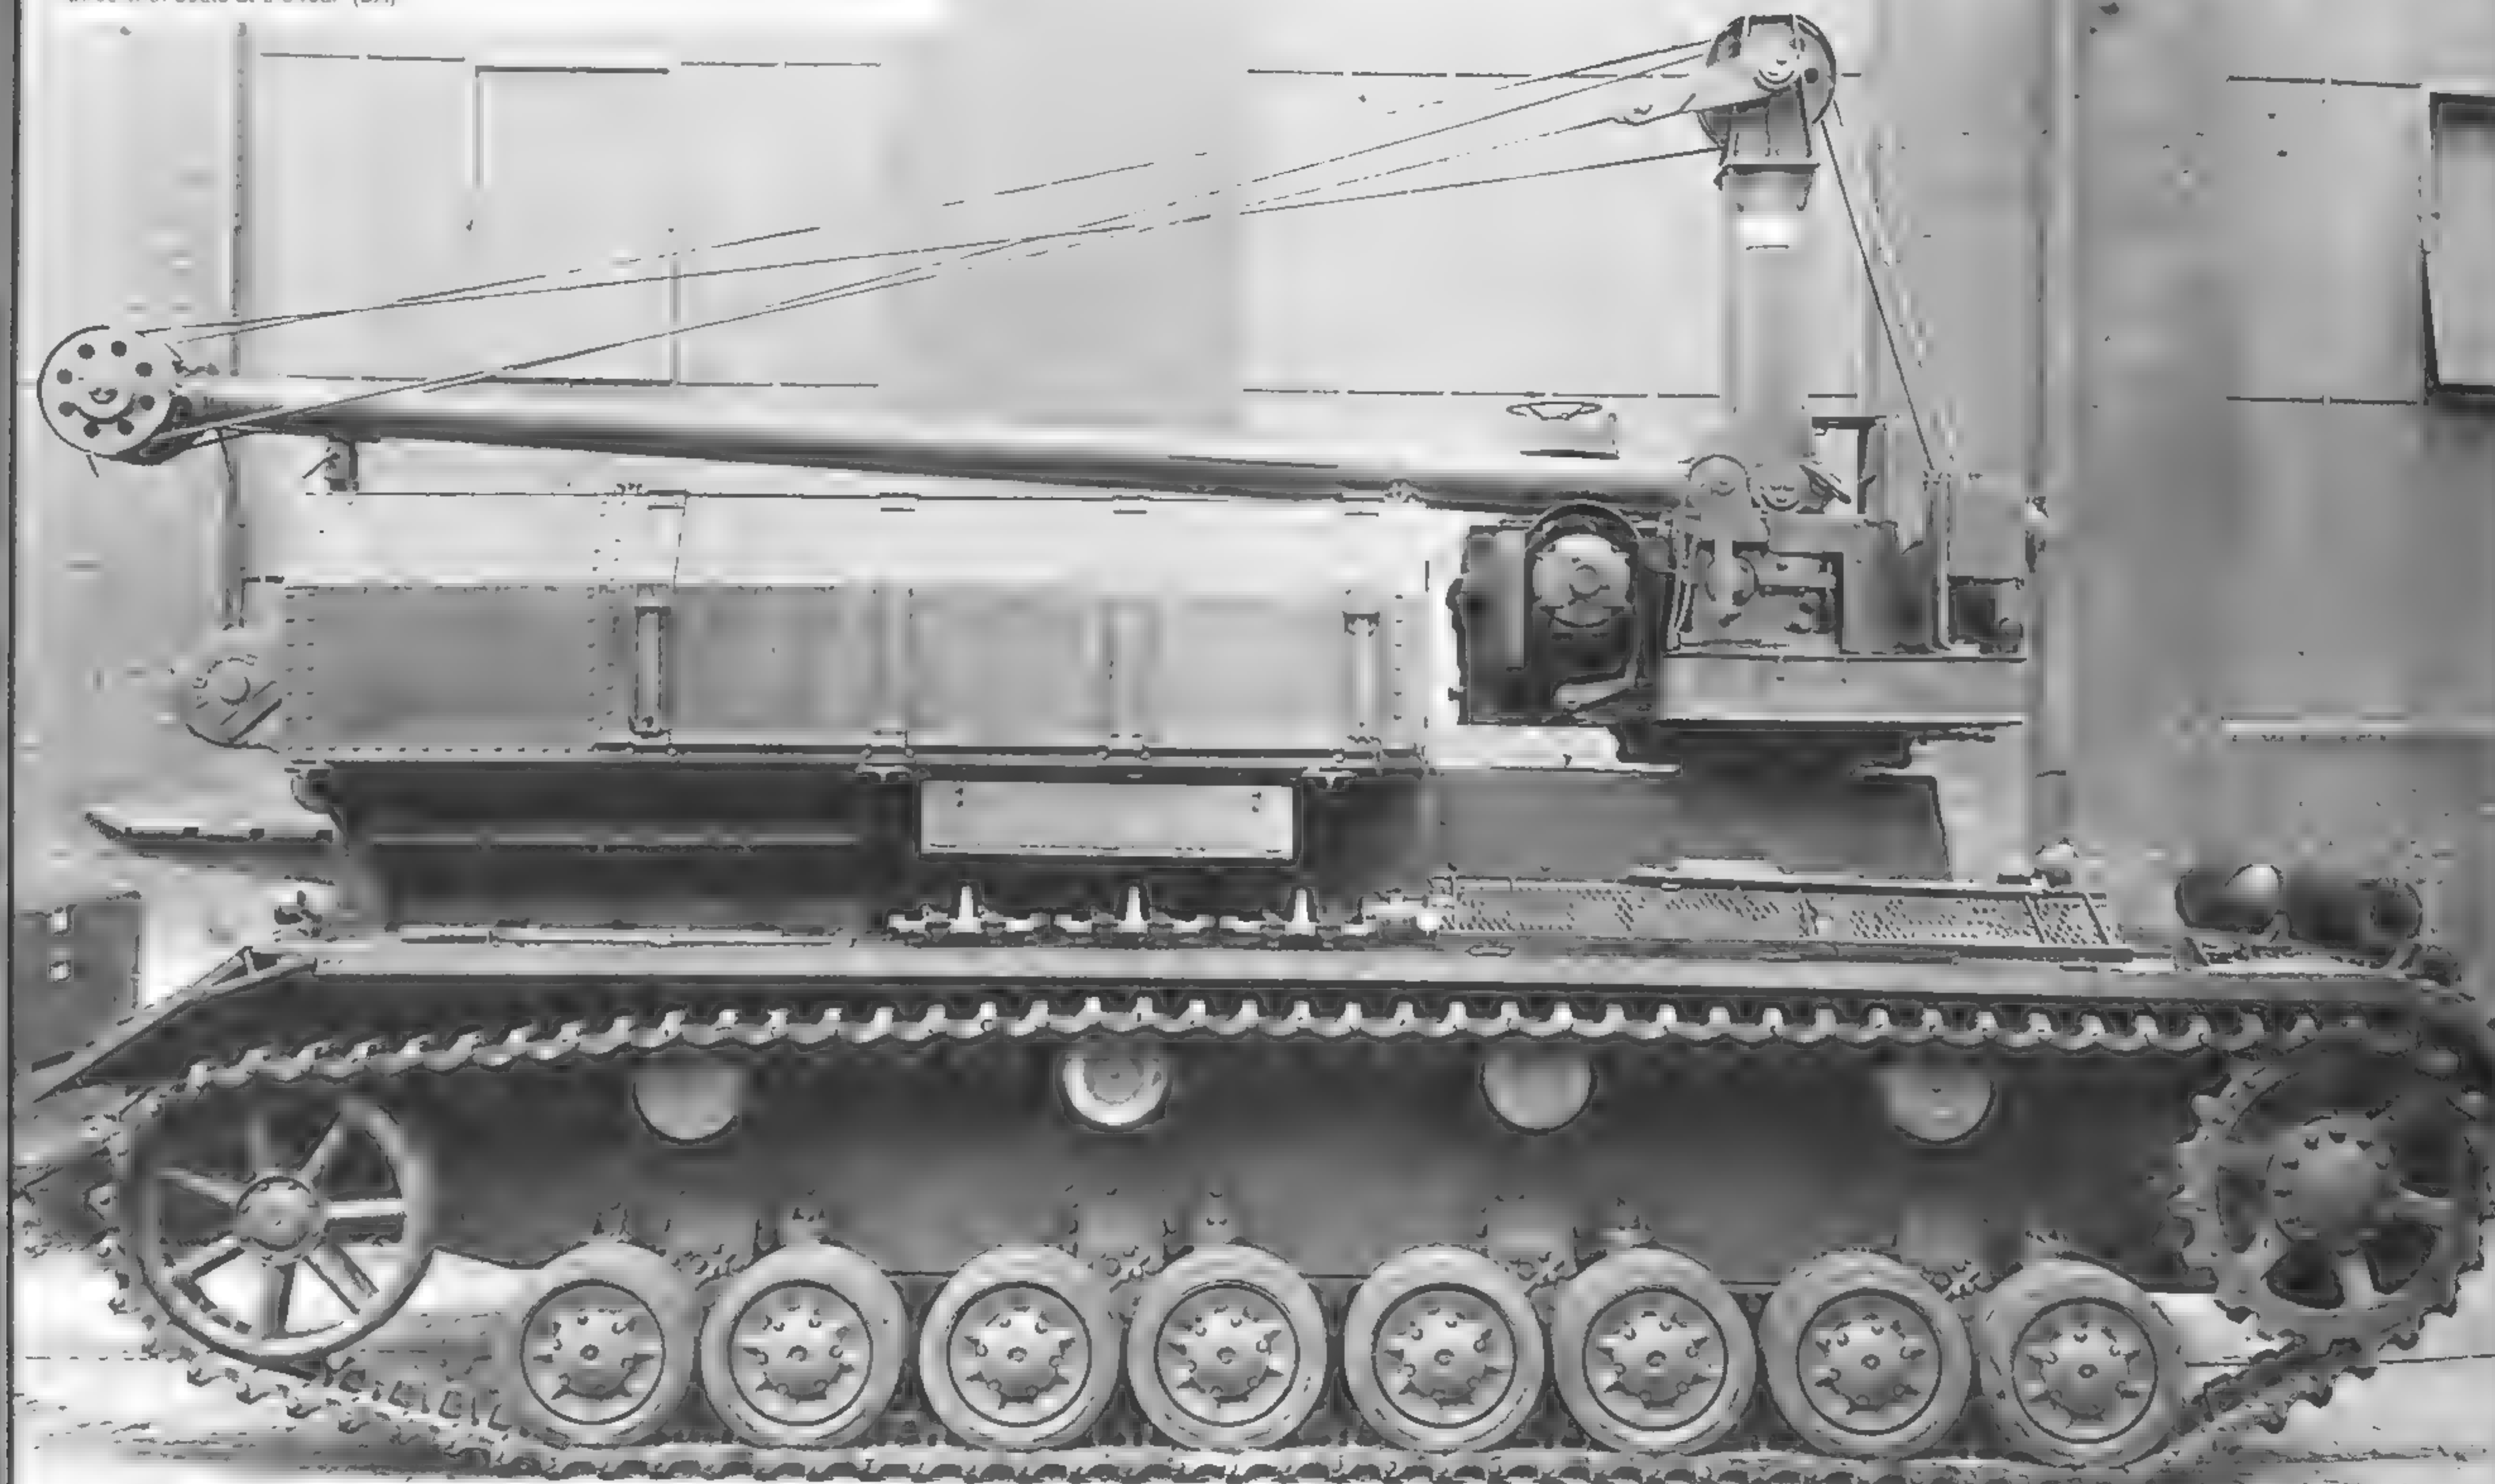
A second Rheinmetall-Borsig factory shot, this time showing the 2.5-ton crane in the travel position. The Munitionsschlepper carried a crew of four, one driving and three with seats at the rear (BA)

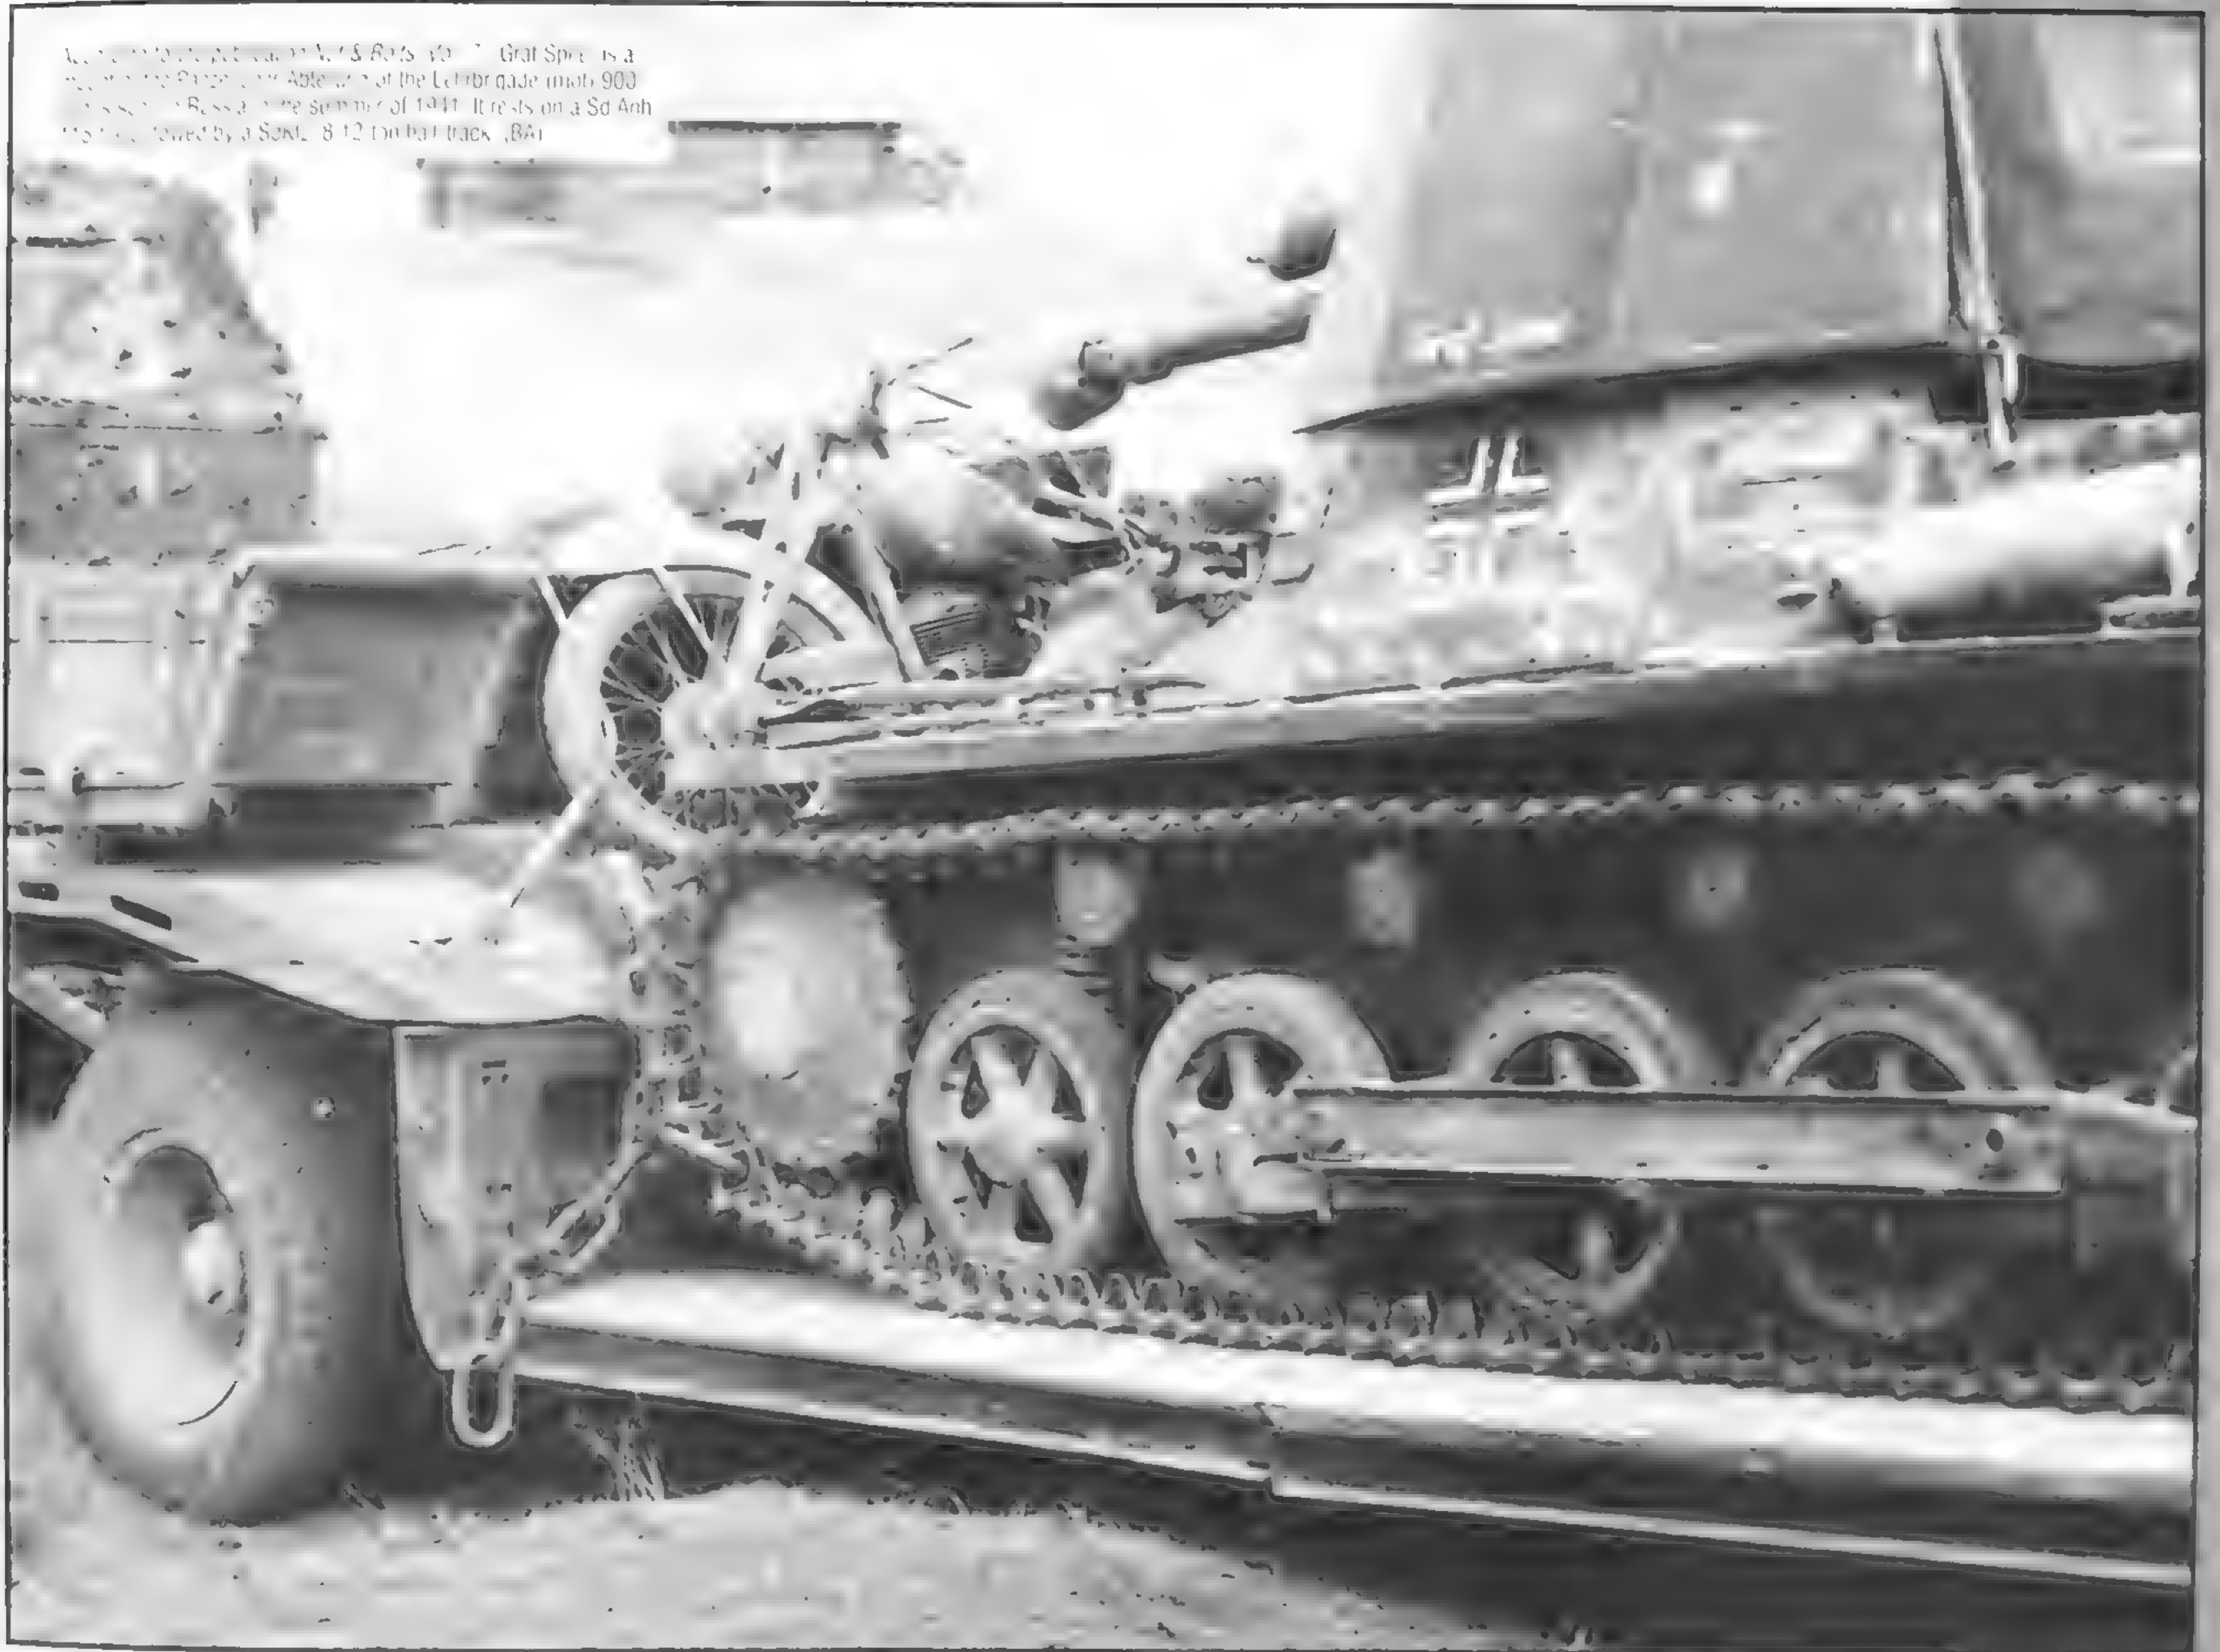
A Panzerjäger I completes the fording of a river in Russia. This gun is most likely assigned to the 543 Panzerjäger Abteilung of the XXIV Motorized Corps in the late summer of 1941. Note how the rear bogie articulates over the log. Logs and other solid debris were often placed on either side of a river ford to add traction to the slick surface created by the passing of multiple armored vehicles. (BA)
